TECHNICAL REPORT GL-85-5

THE VAIONT SLIDE, A GEOTECHNICAL ANALYSIS BASED ON NEW GEOLOGIC OBSERVATIONS OF THE FAILURE SURFACE

Volume I
MAIN TEXT

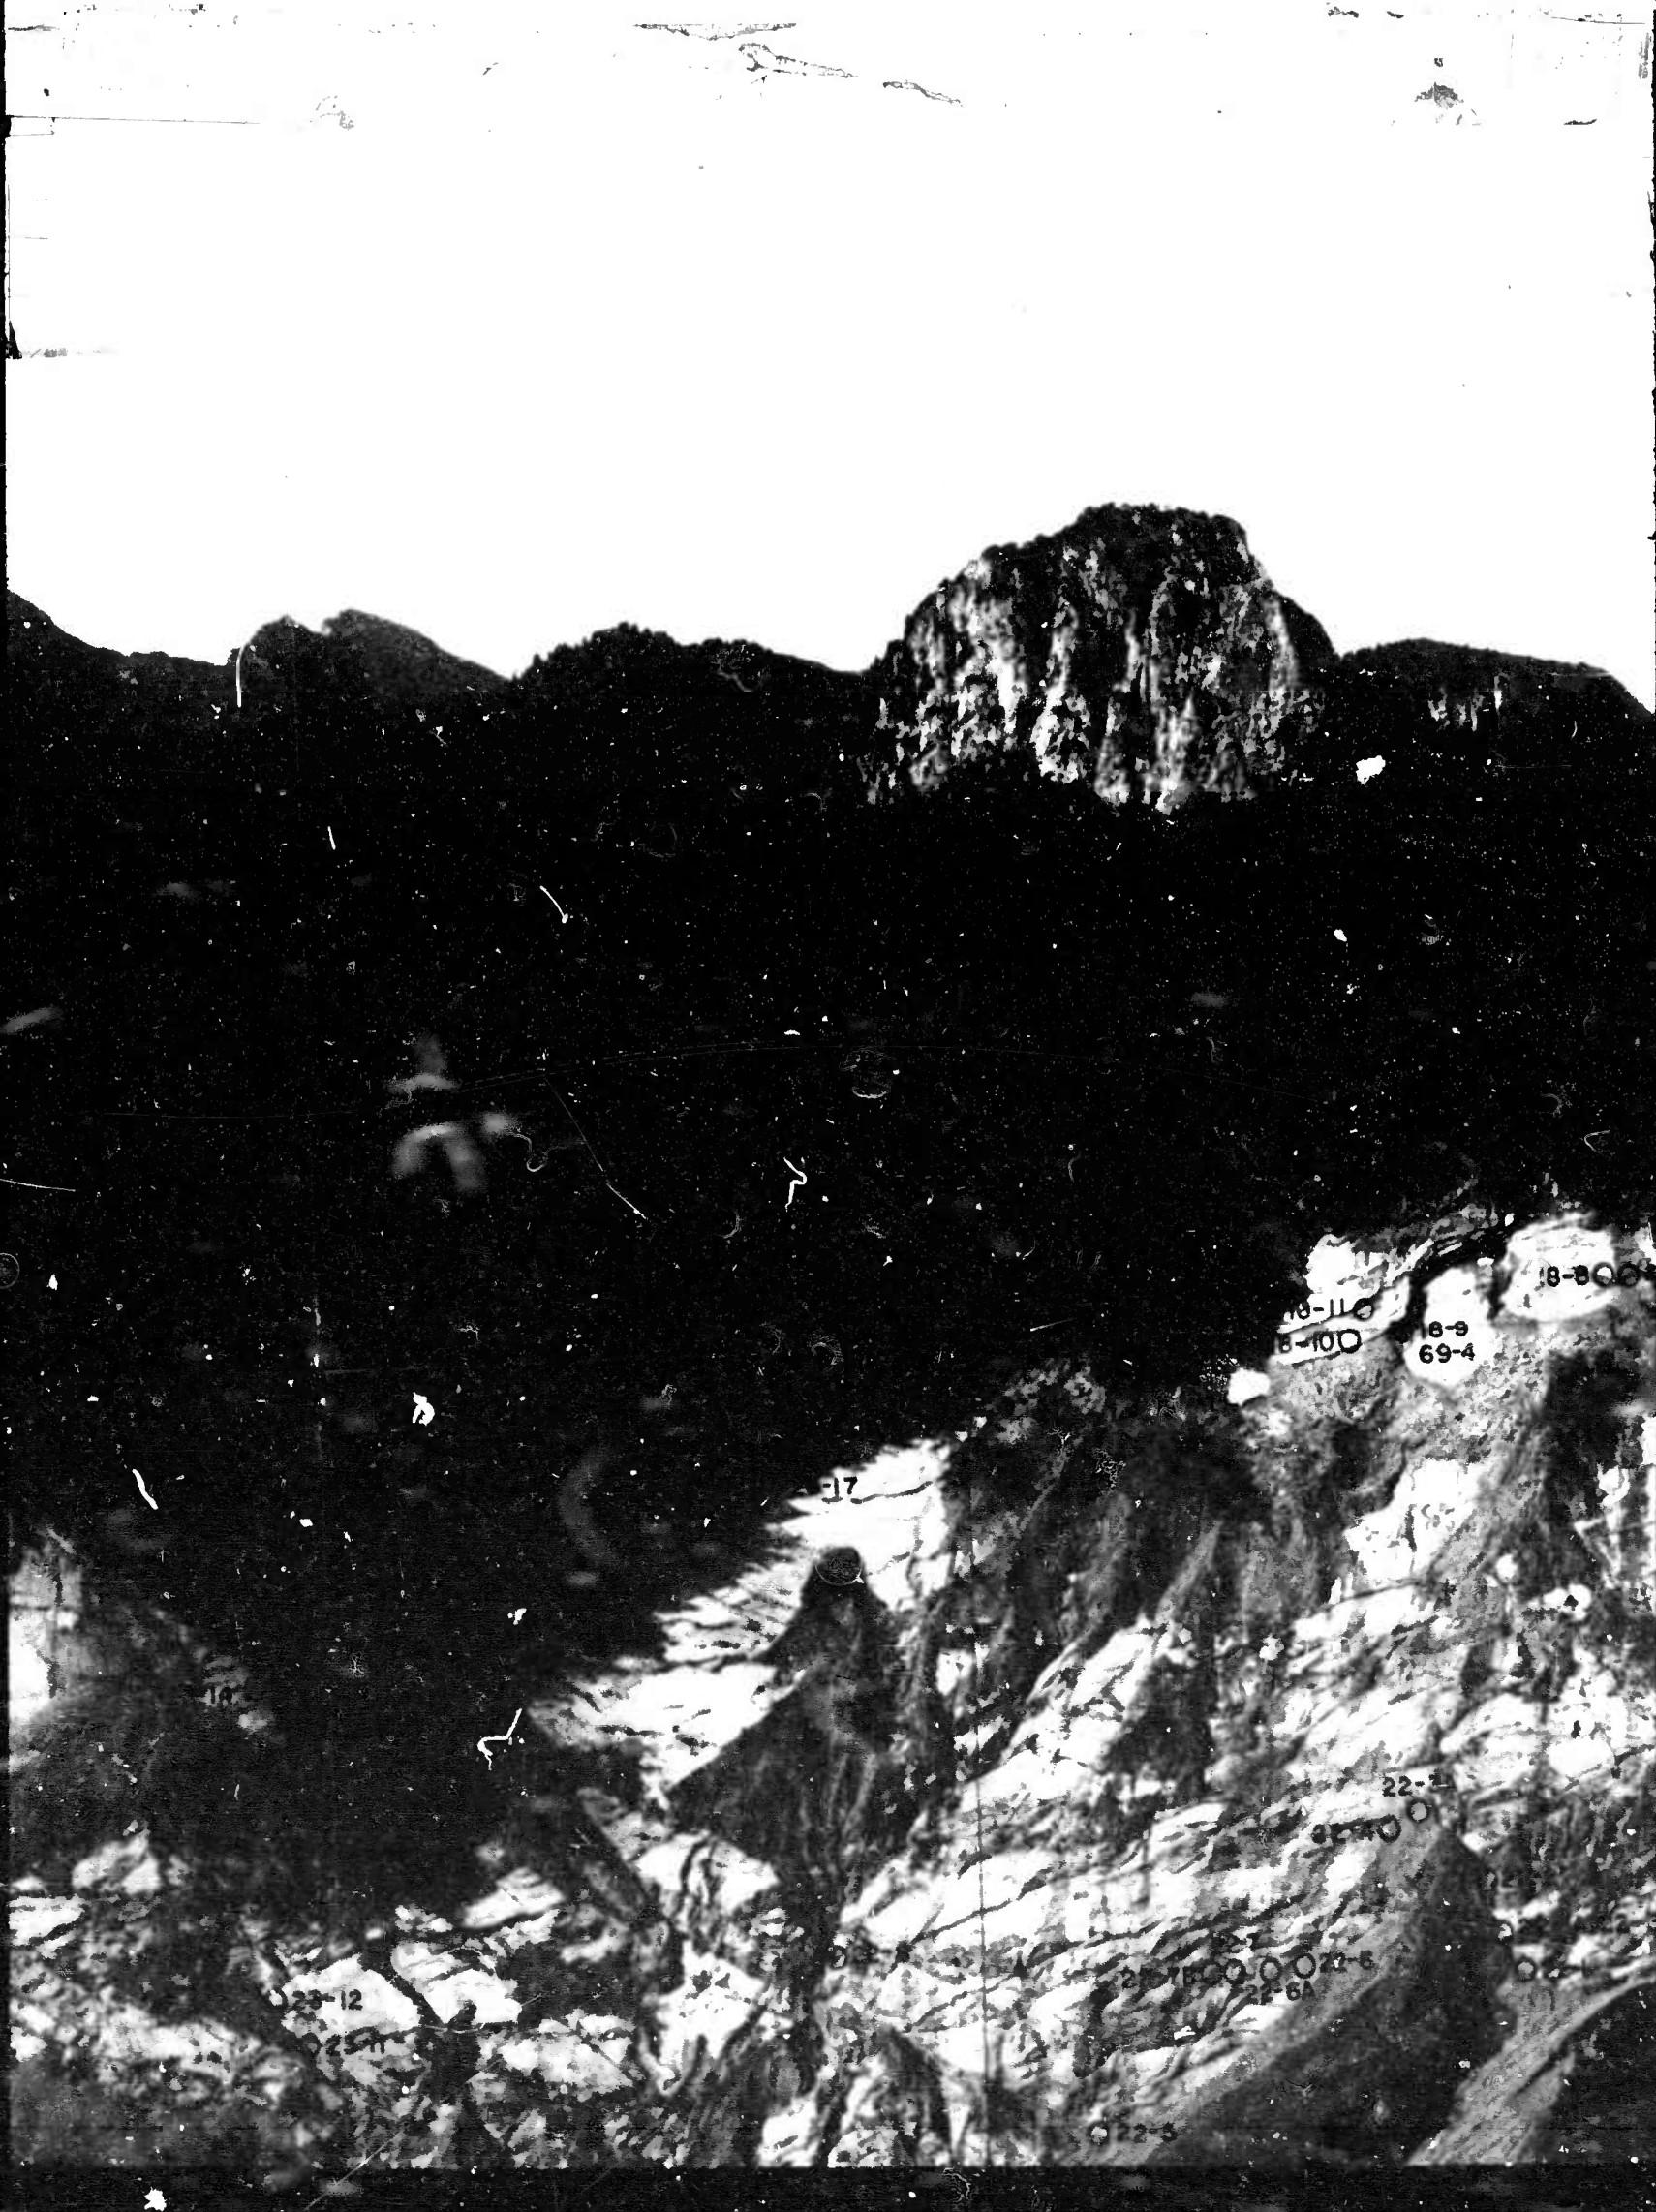
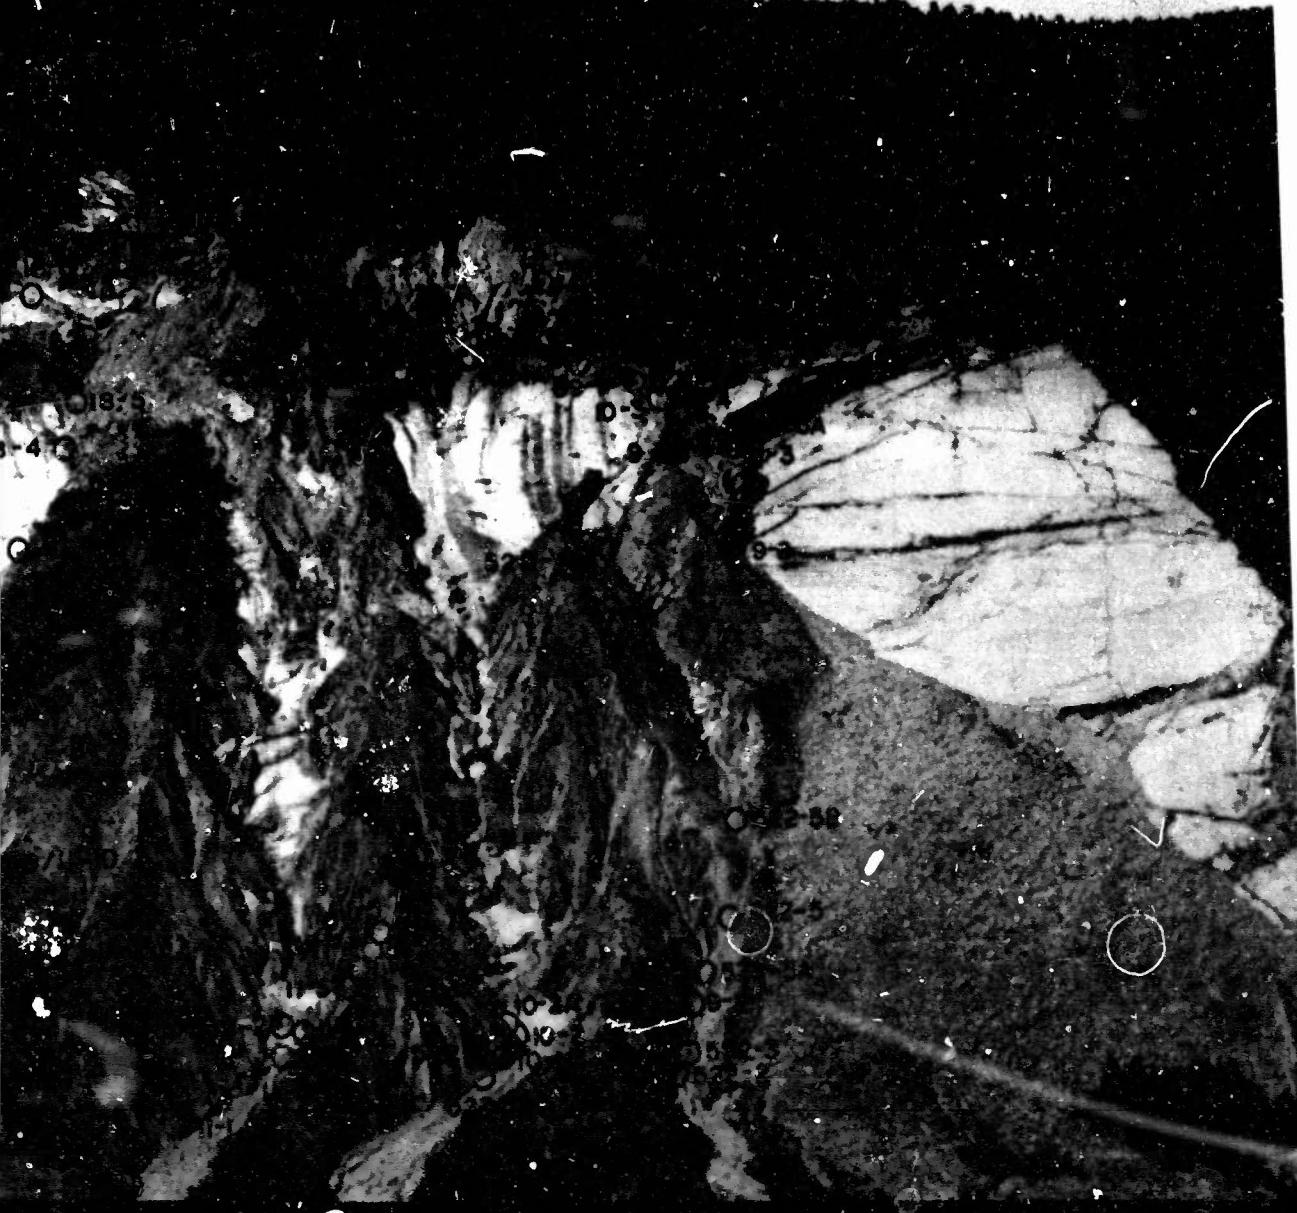
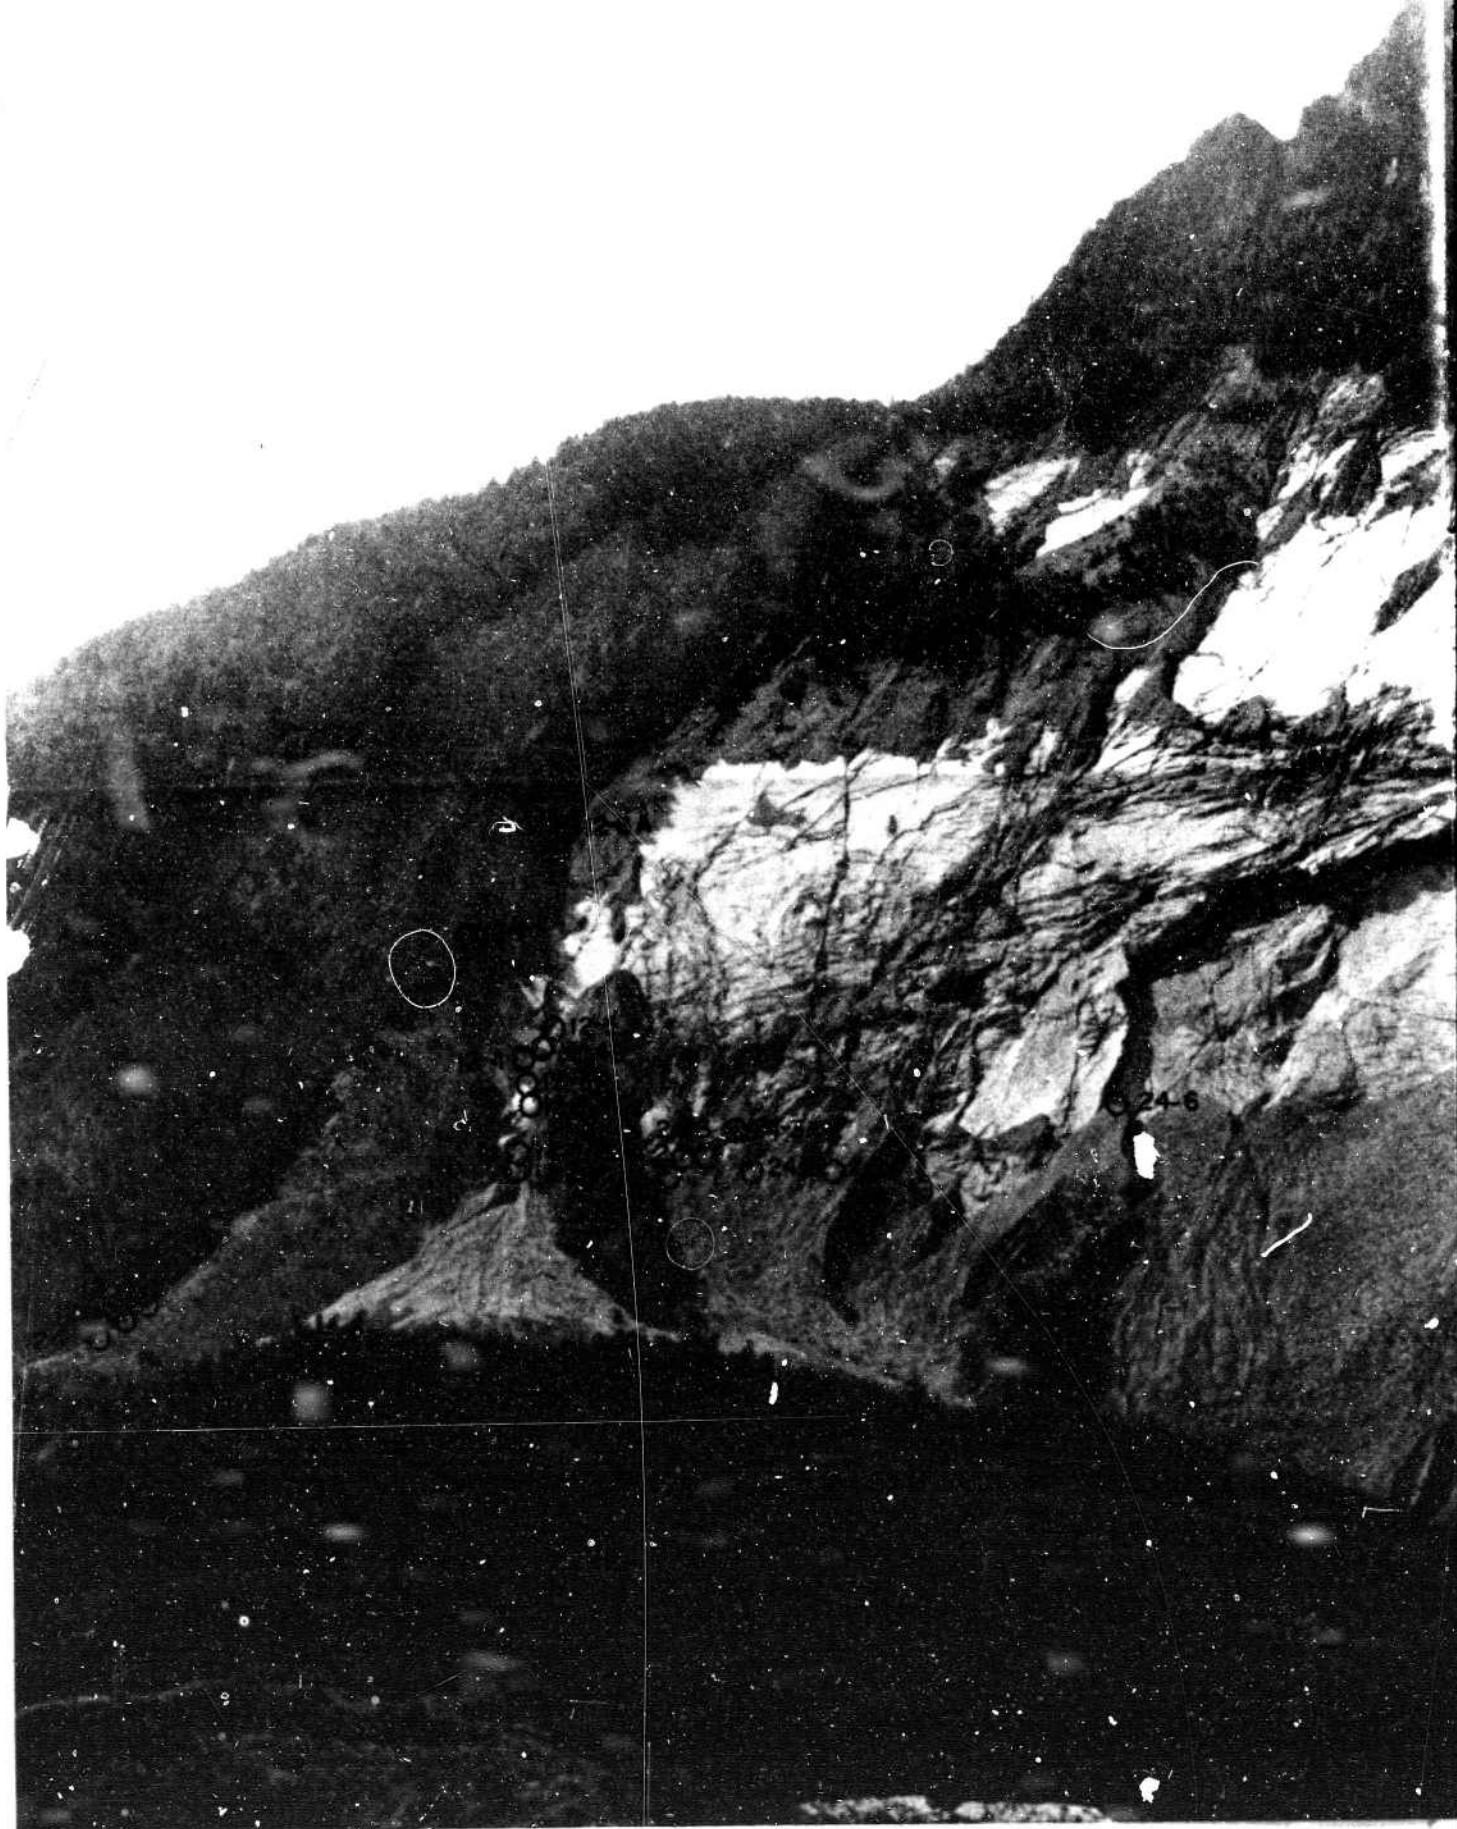
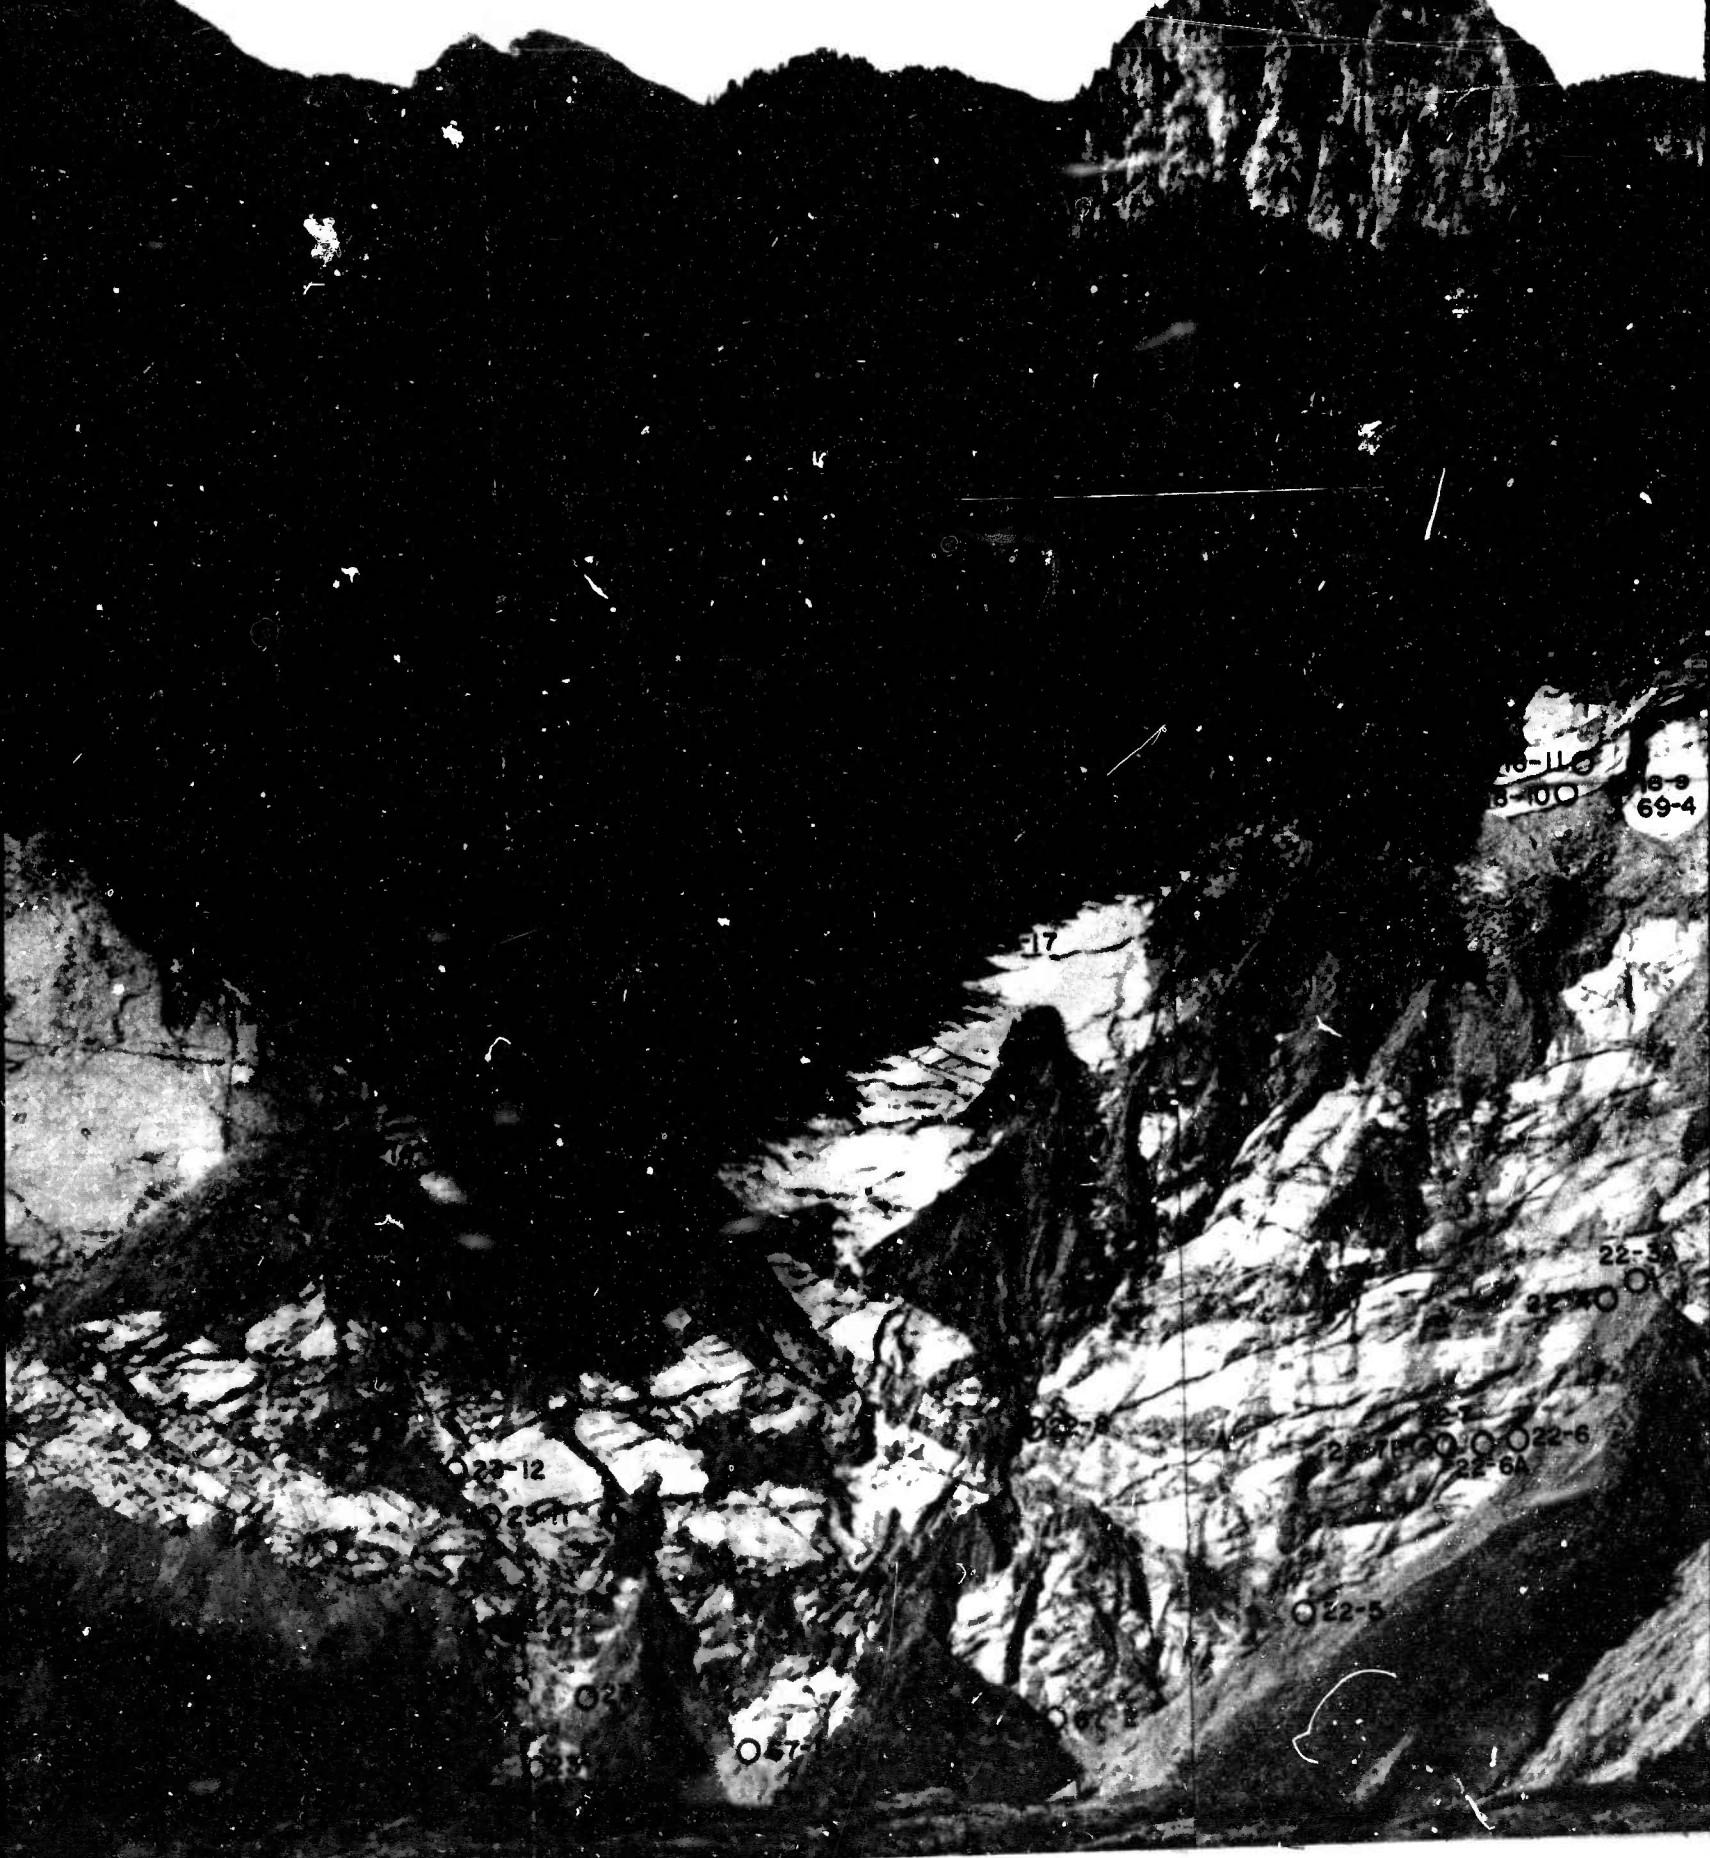
FIGURE 13
Photomosaic of the
Upper Portion of the Valont Slide
